## Woodward Creek Visual Survey

Kevin McAuliff / Jimmy Davis; Thursday, September 16, 2010; Weather: Clear and sunny, temperature in the 80's.

**Updated July 21, 2011, Kevin McAuliff.**

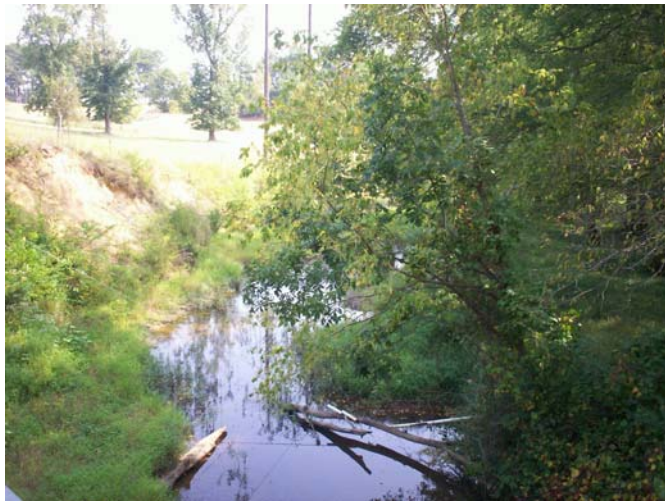
Bells Ferry Road View Upstream. A herd of cows was grazing above the precipitously eroded bank to the left.

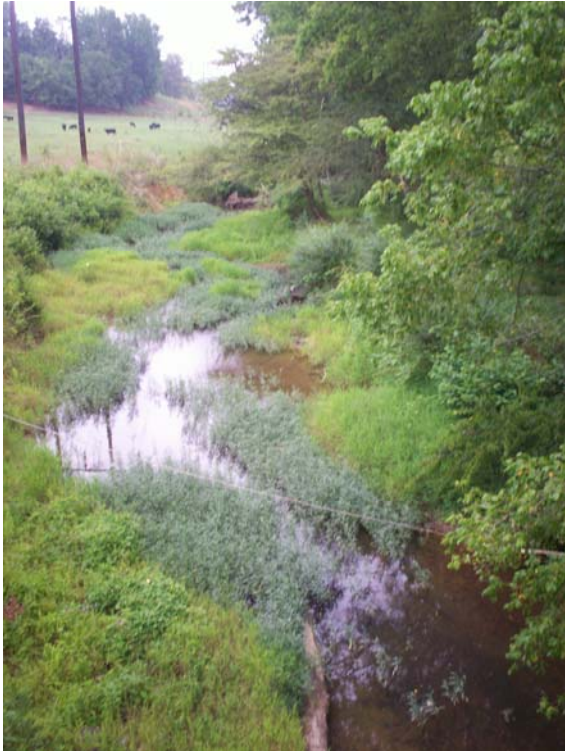
Bells Ferry Road Upstream: Water was higher than last year, and there was much aquatic vegetation. As was the case last year, a herd of cows was grazing above the precipitously eroded bank on the left.

NWGRC staff re-surveying Woodward Creek found conditions at the Bells Ferry crossing not significantly changed from the previous year.

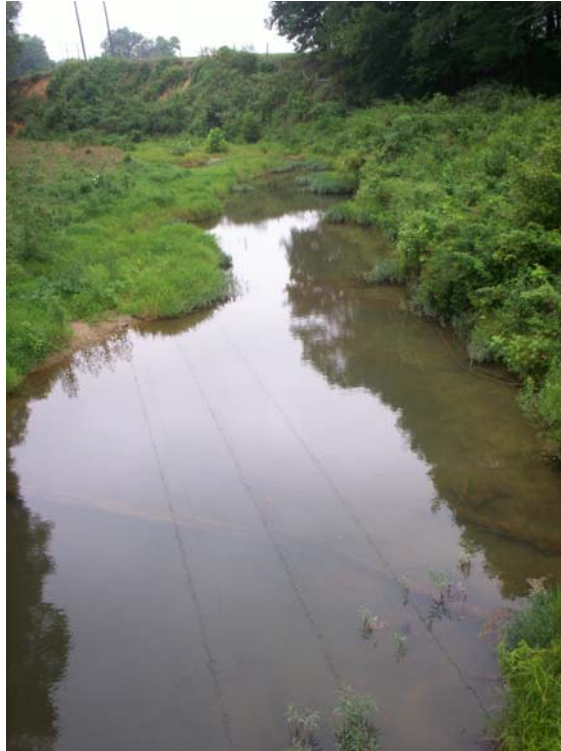
Bells Ferry Downstream. Water higher and clearer than last year.

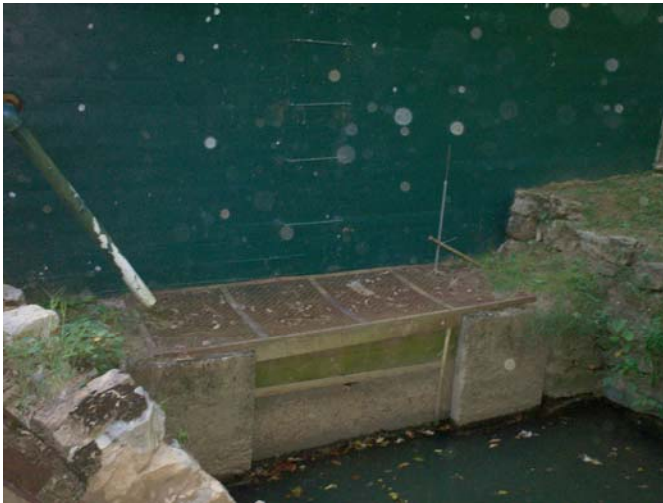
Water intake

Water at **the intake in Shannon** is slow flowing and tea colored, but clear. The surrounding area is wooded up to the creek bank, with no pasture or other potential non-wildlife sources of fecal coliform noted. Periodically, flows at this location drop low enough for the intake to be shut down.

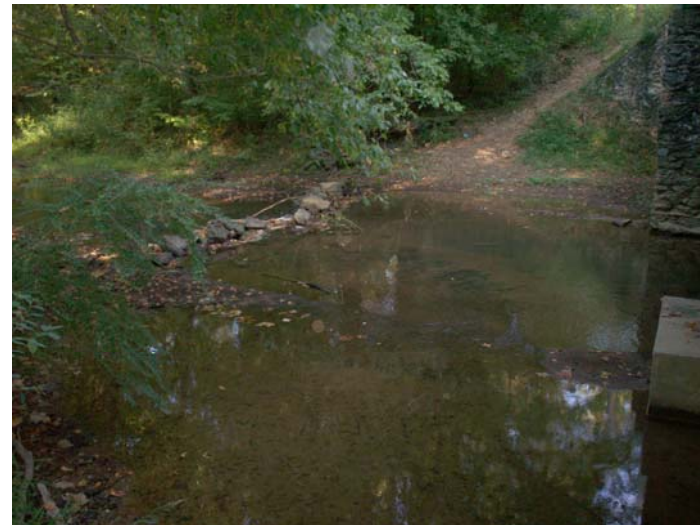
Swimming hole

The **Minshew Road crossing** is in a wooded area that appears to be somewhat isolated, though there is a nearby lake, formerly used for recreation. Just downstream from the bridge, is an informal rock dam, apparently intended to raise the water level to create a swimming hole. The water at the site is shallow, tea-colored, and clear. No pasture land or other potential non-wildlife source of fecal coliform is evident in the vicinity, and there are no residences nearby.

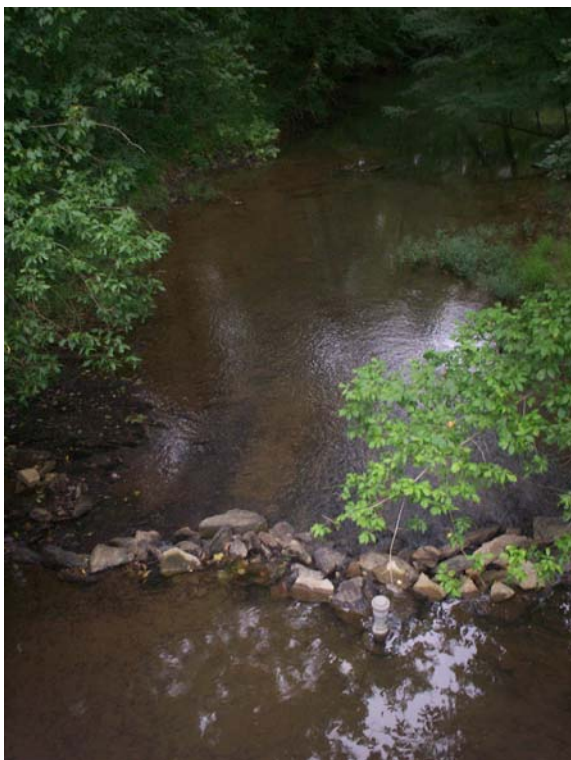
Minshew Road Crossing view downstream.  
Swimming hole is still there.

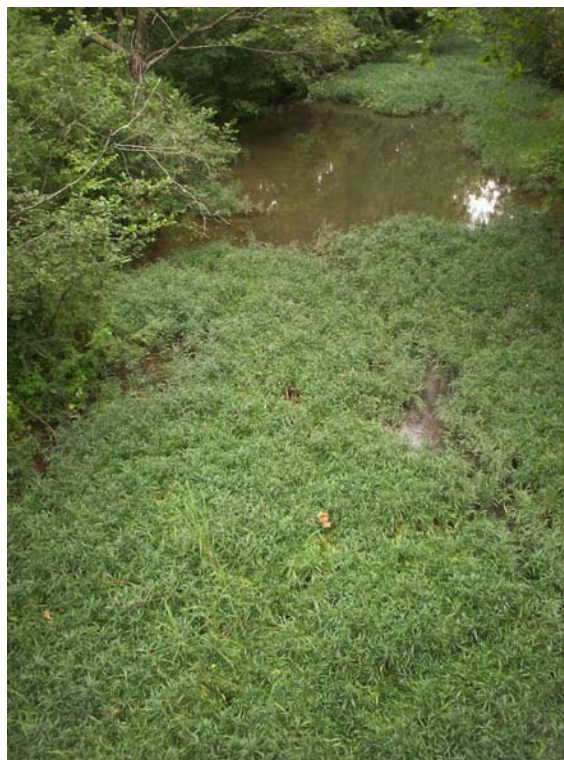
Minshew Road Crossing view upstream.  
The considerable aquatic vegetation was  
not present at the time of the visual survey  
in 2010.

NWGRC staff re-surveying  
Woodward Creek found  
conditions at the Minshew Road  
Crossing not significantly changed  
from the previous year. The water  
was higher and clearer, and there  
was much aquatic vegetation.

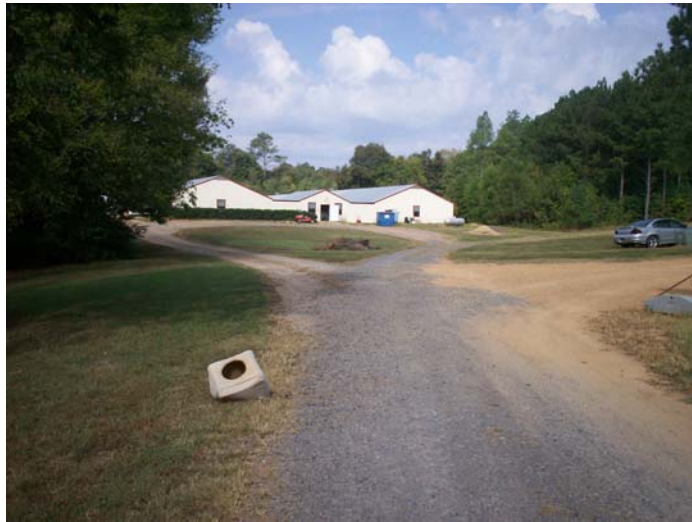
Chicken houses

**Southwest of the intersection of Highway 140 and Thomas Bluff Road**, in a pine plantation, are two very large and modern chicken houses. According to the USGS Topographic Map, the chicken houses appear to be situated above or in a draw that drains into Woodward Creek. A branch downhill from the houses was evident on the property. There was no smell detectable on the property, but that the houses were modern and evidently very well-maintained, suggests that they are in use.

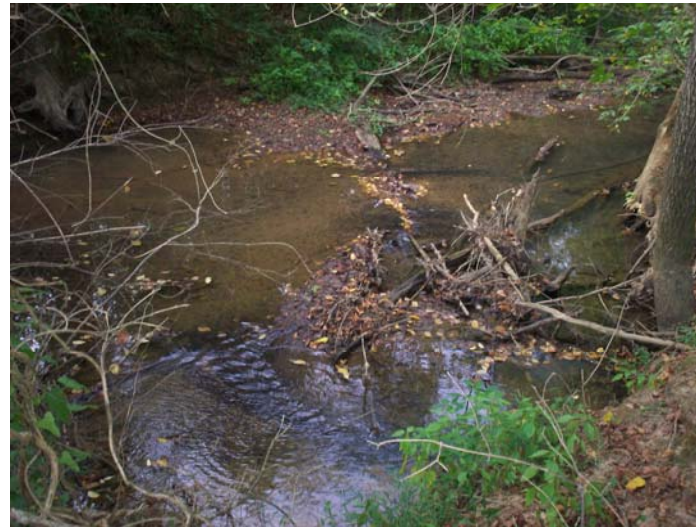
Branch below chicken houses

Water in the branch was shallow and clear.

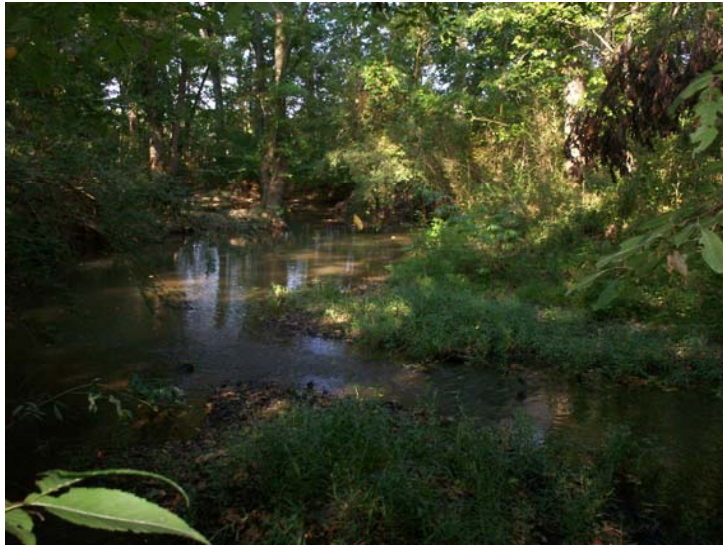
View downstream, with clearing visible in the distance.

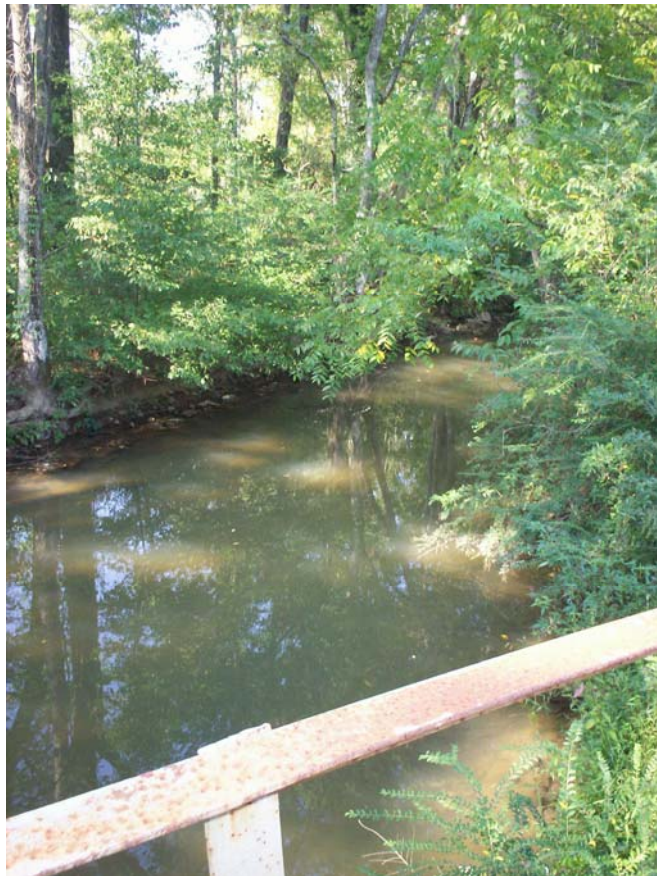
View downstream from the Gaines Loop crossing

**The Gaines Loop (USGS: Dixon Road) crossing** is located upstream from the Earle property, southeast of Gaines Loop. The water is shallow, tea-colored, and clear. There are residential uses nearby, and a hayfield near the creek buffered by trees. Trails cross the tree buffer and slides down the bank are evidence that wildlife access the creek at this point. There is agricultural land in the vicinity, and there were herds on both the north and south sides of the road on the east side of the creek. It was not evident from the public right-of-way whether the cattle are fenced out of the creek or not.

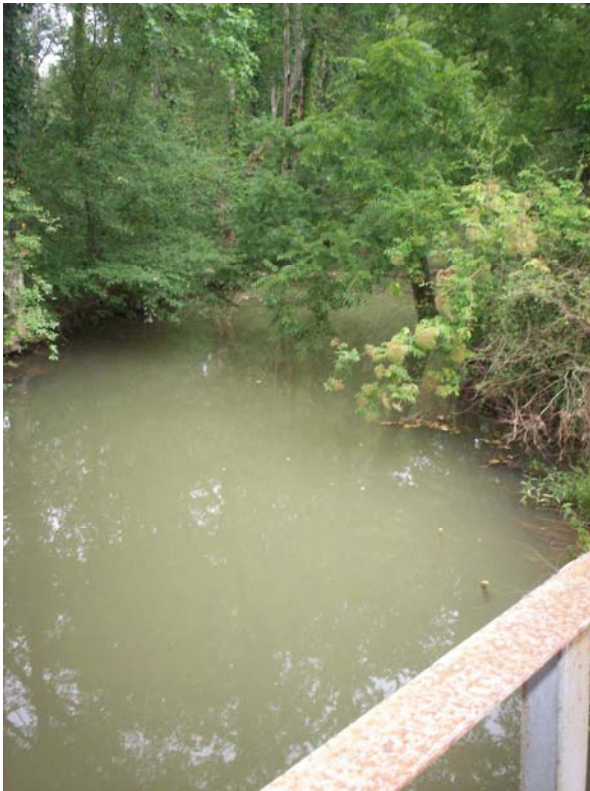
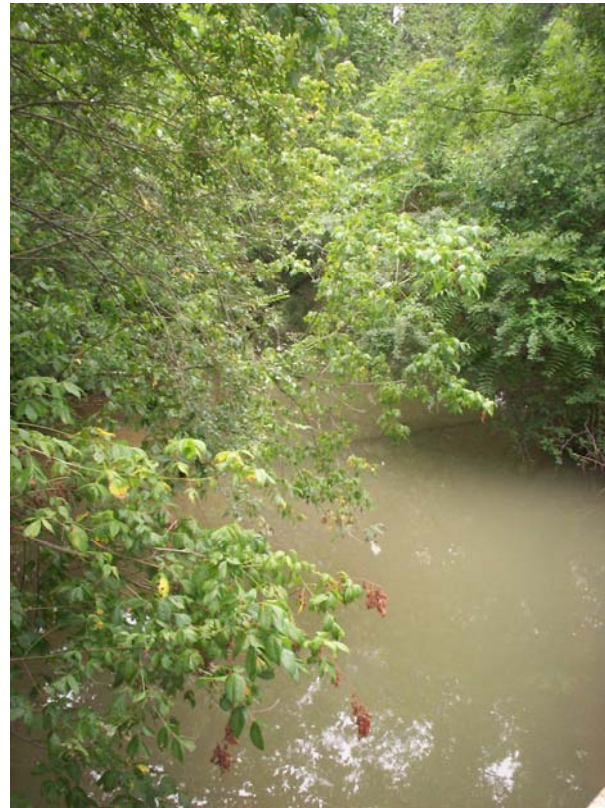
Gaines Loop crossing view downstream.

Gaines Loop crossing view upstream.

NWGRC staff re-surveying Woodward Creek found conditions at the Gaines Loop Crossing not significantly changed from the previous year. The water was higher and murky, and the hayfield was overgrown.

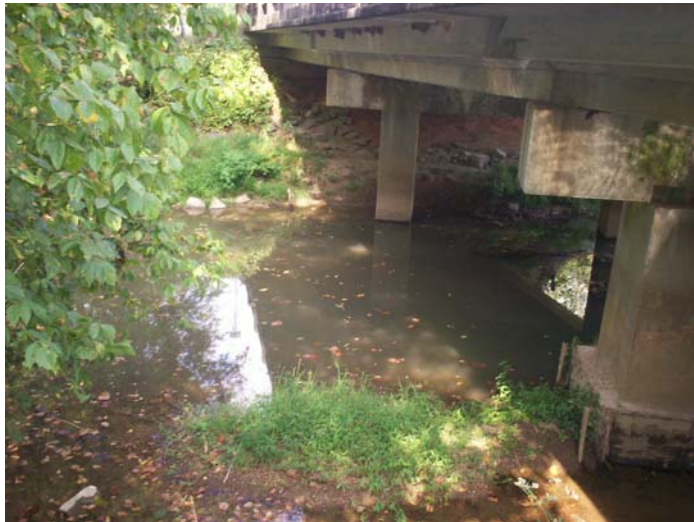
View below bridge

**The Highway 140 crossing** on Woodward Creek is situated upstream from the Dixon Road/Gaines Loop crossing. The flow is sluggish, and the water cloudy, an appearance possibly due to the depth of the water at the bridge, since it does not appear cloudy in shallower stretches downstream. At the crossing, the creek flows through woods, but there are nearby agricultural uses, including the four vacant chicken houses noted above, and vacant pastures.

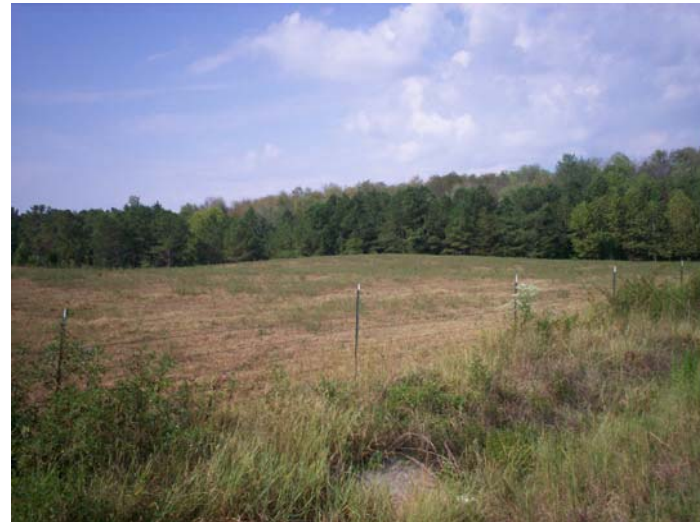
Disused pasture near creek

From the limited vantage afforded by the public right-of-way, there does not appear to be much livestock in the vicinity, or throughout much of this watershed, and pastures and hayfields here and elsewhere appear to be severely drought ravaged.

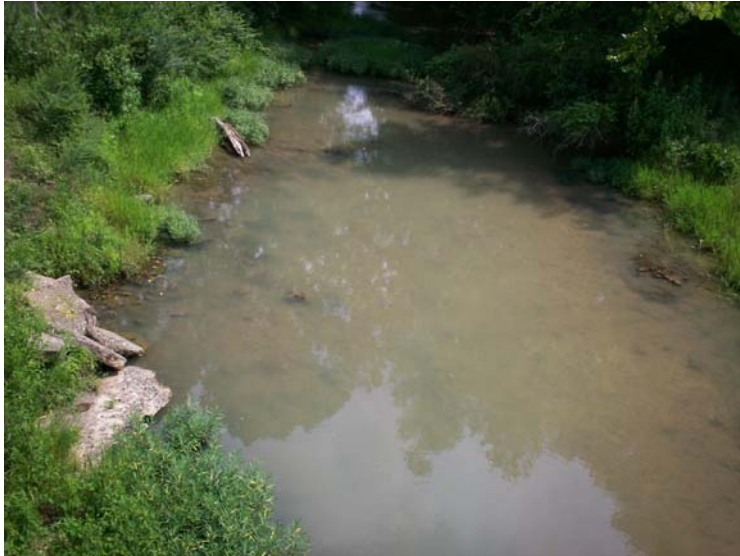
Above: View upstream at Hwy 140 crossing.

The water was higher than the previous year, and somewhat murky. Last year, no cattle were seen. There was no significant change in the vicinity of the crossing since the 2011 visual survey.

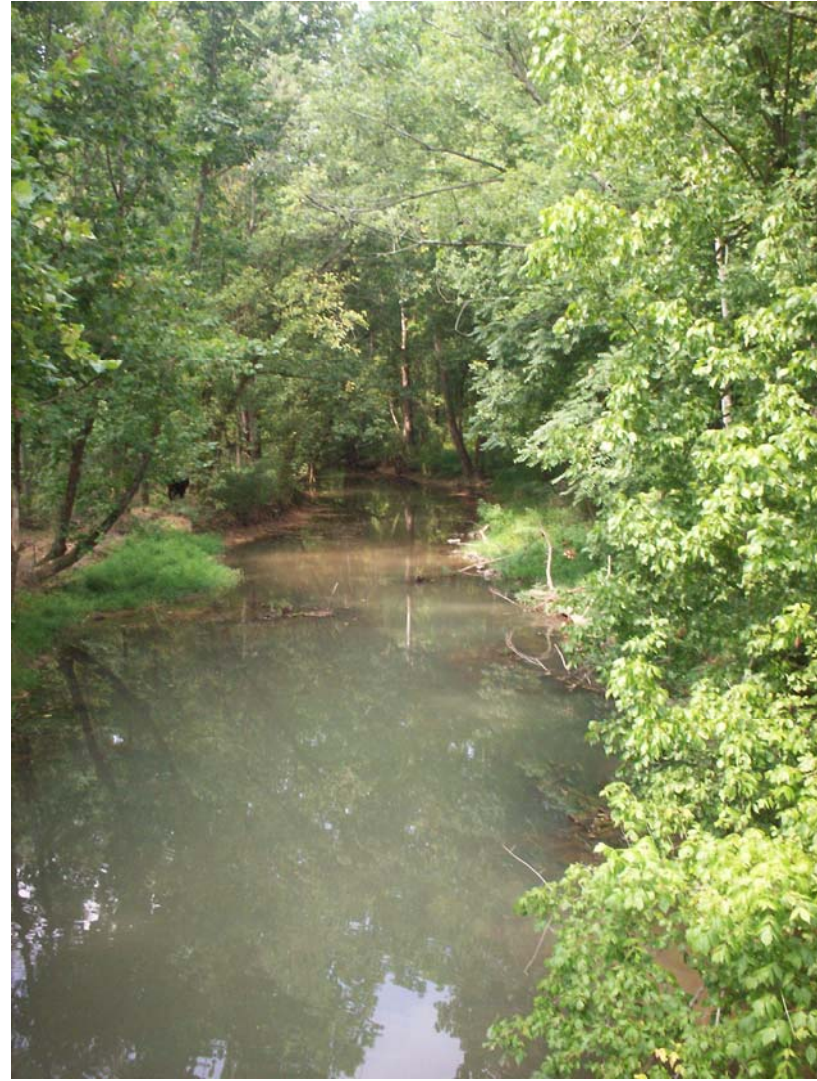
Right: View downstream at Hwy 140 crossing. A cow is visible as a black dot on the bank to the left of center. There appears to be a fence above the bank.

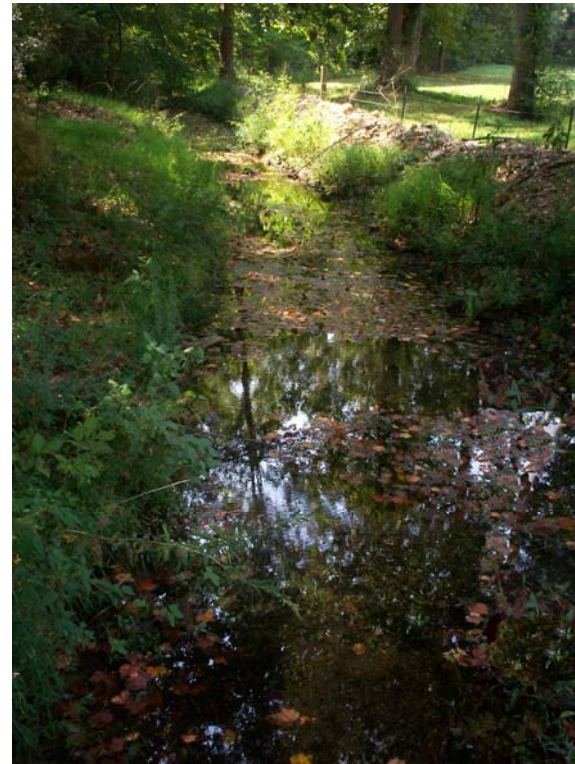
Downstream view of Woodward Creek at the Autry Road crossing.

At the crossing on the day of the site visit (September 23, 2010), there was a shallow pool on the upstream side of the bridge, but the bed appeared to be dry as far as it was visible from that point. The water was clear, but had little flow.

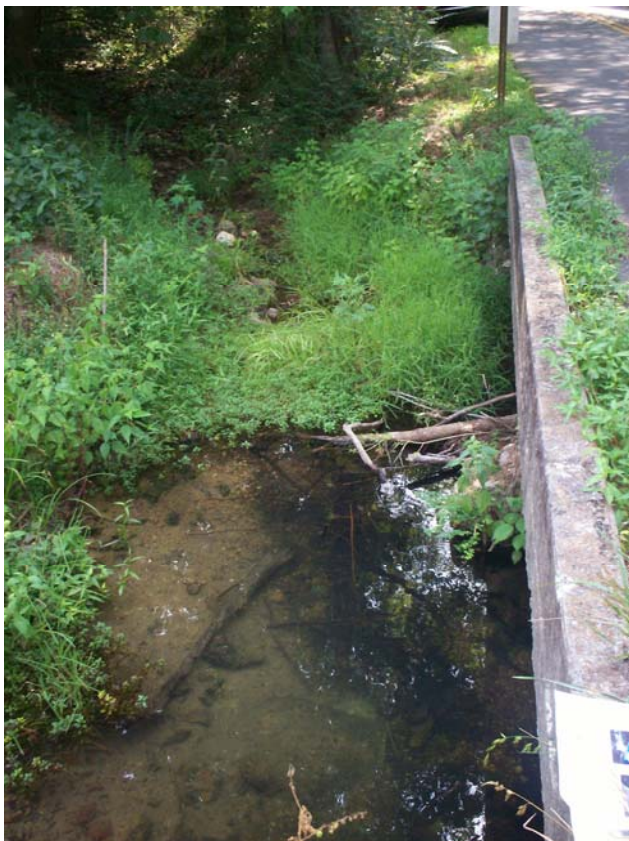
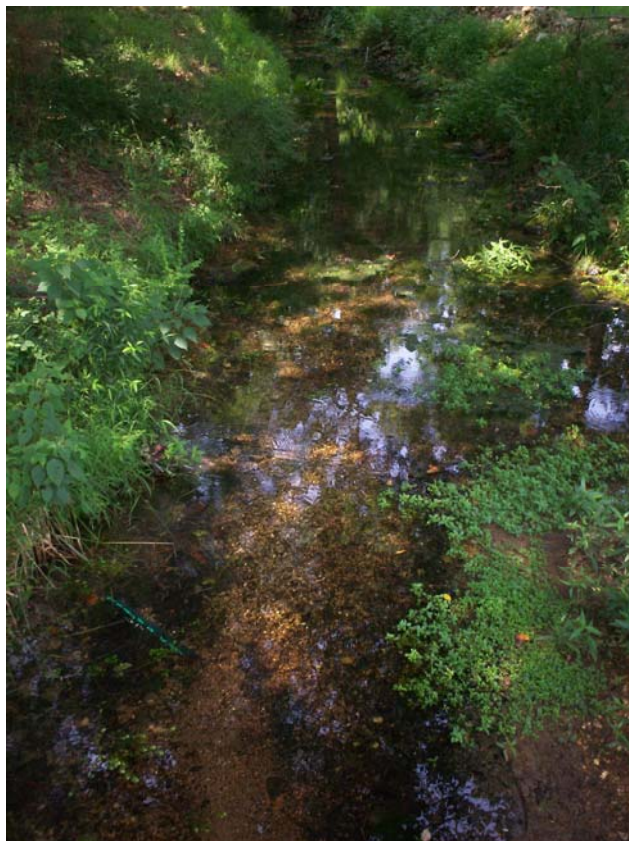
View upstream at the Autry Road crossing.

View downstream at the Autry Road crossing.

NWGRC staff noticed no significant changes from last year at this crossing. That there was water at the 2011 visit was a simple function of weather.
