2015

DYKES CREEK WATERSHED MANAGEMENT PLAN

Dykes Creek Management Plan

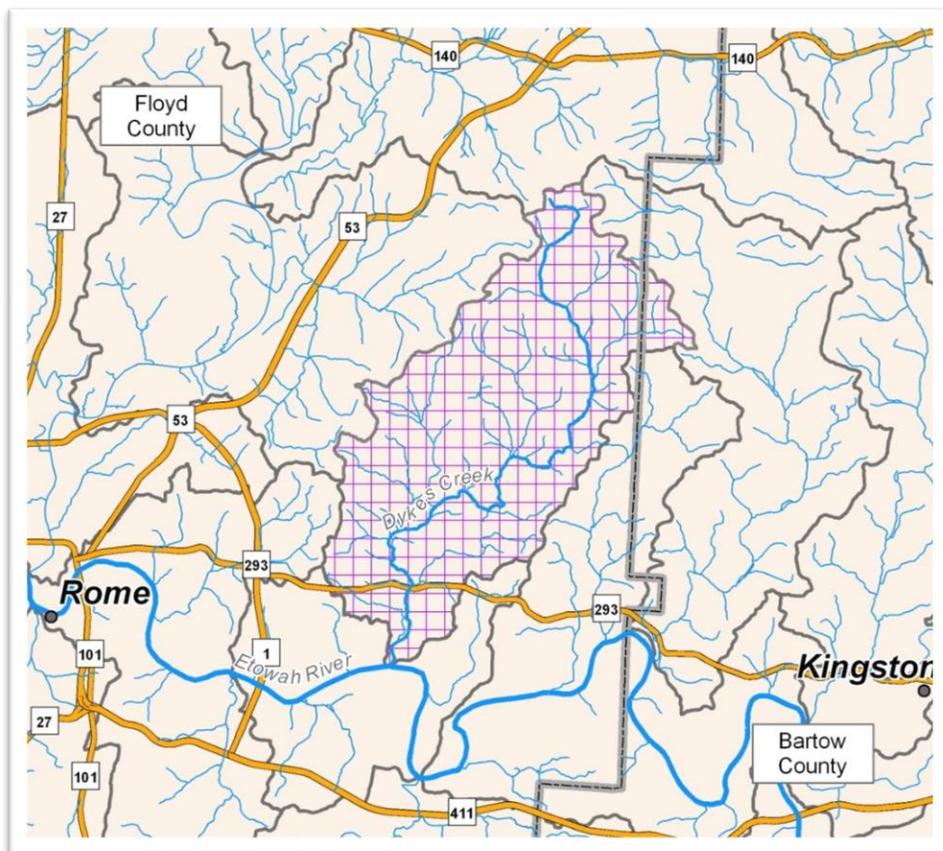
Figure 2.1. Map of Dykes Creek watershed, Floyd and Bartow Counties, Georgia

Dykes Creek begins in Floyd County near the foot of the eastern side of Armstrong Mountain. The creek flows southward, collecting the drainage from the eastern sides of Armstrong and Ward Mountains, which are probably the most prominent topographical features in the watershed. Dykes Creek continues south by southeast, flowing through Halls Lake, a man-made reservoir in the Morrison Campground area, and continuing southward to the Etowah River. The watershed drains an area of 10,944 acres. The watershed is shown in Figure 2.1, with the main stem of the creek shown in dark blue, and many unnamed tributaries in light blue shown entering the creek as it flows southward.

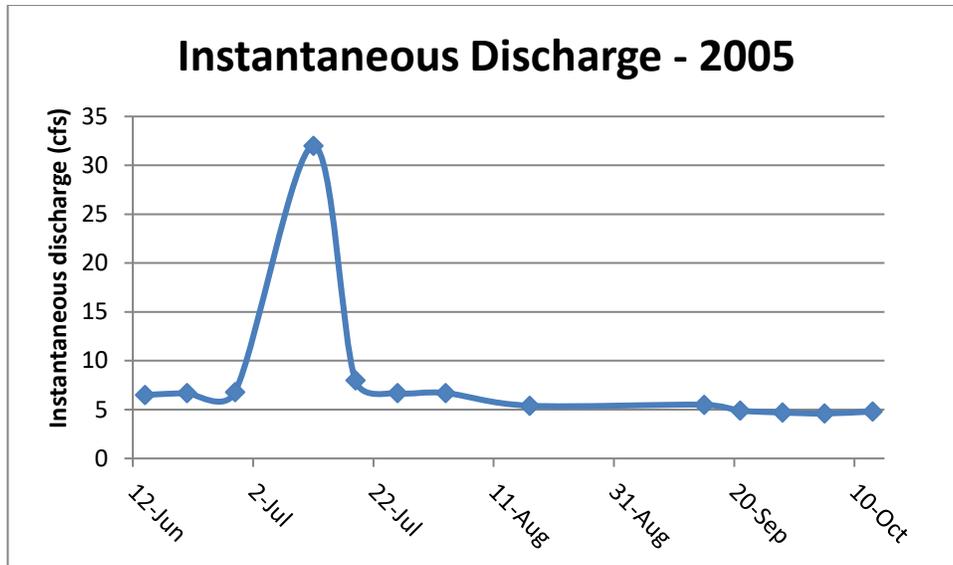
Figure 2.2 A display of the instantaneous discharge (flow) in Dykes Creek at Kingston Highway (SR 293) during summer and fall of 2005. Source: USGS

Stream flow data at Kingston Highway Bridge, in the lower perennial reaches was collected with water quality data in 2005 by the state and is shown in Figure 2.2. Dykes Creek is a small stream with non-storm flows below 5 cubic feet/second (cfs), but when storms do occur, the flow can swell to values in the 30's or higher. A USGS gage was located off of Fred Kelly Road just upstream of the Kingston Highway site in the 1930's and 1940's, and the mean monthly discharge in Figure 2.3 shows similar summertime flows. Although the stream flow data in Figure 2.3 is many decades old, it shows that heavy winter and spring storms combined with lack of water uptake by dormant deciduous trees can cause surges in stream flow that are many times higher than base flow.

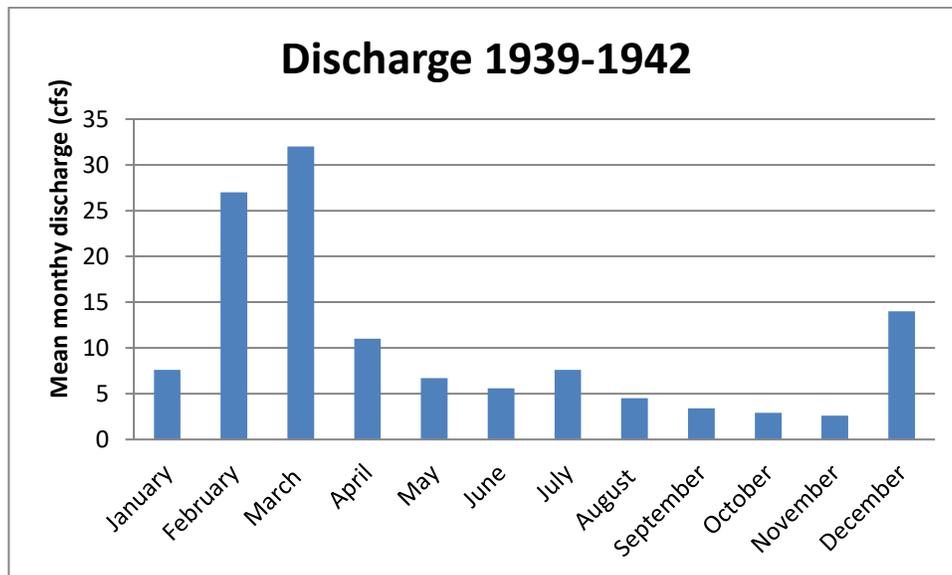
Figure 2.3. A display of the mean monthly discharge (flow) for Dykes Creek off of Fred Kelly Road for the years 1932-1942. Source: USGS

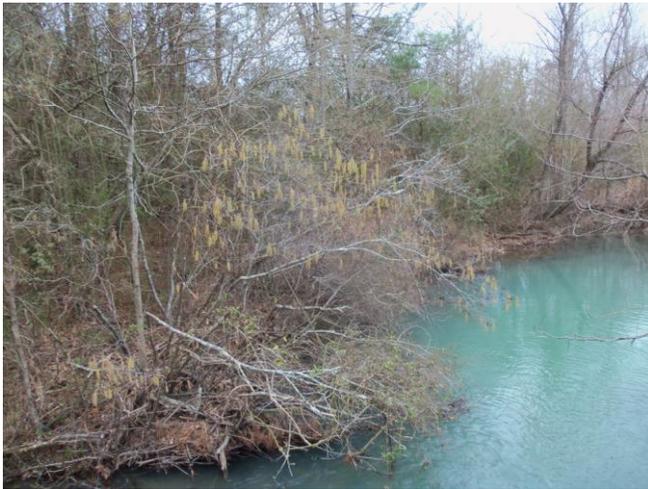
Figure 2.4. Alder in bloom at Wayside Road crossing of Dykes Creek (DC 8). Note milky appearance of water at this site.

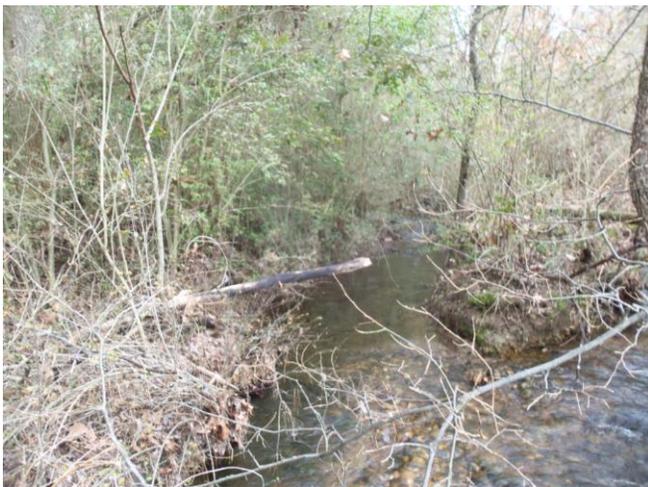
Figure 2.5. Thick stand of Chinese privet at Gentry Road tributary (DC 5).

Forest cover, at 65.9%, is the largest land use category in the Dykes Creek watershed. In general, in the Ridge and Valley Province, forests are mixed conifer and hardwoods. Ridges tend to have hardwoods and the valleys and lower slopes include loblolly and Virginia pines (Georgia Statewide Assessment of Forest Resources). On the slopes hardwood species include oaks and hickories, with a variety of other species such as maples, dogwood, and sourwood. In the stream valleys a large diversity of tree species can be found, including tulip poplar, beech, elms, ashes, box elder, red maple, black walnut and sycamore (Norman, 2000). In the Dykes Creek riparian zone, trees observed at sampling sites include oaks (such as water oak), loblolly pine, eastern red cedar, sweetgum, hackberry, sycamore, willow, alder (see Figure 2.4) and lots of invasive Chinese privet. In fact, Chinese privet is present at each of the nine sites and dominates the understory at several of the sites (Figure 2.5).

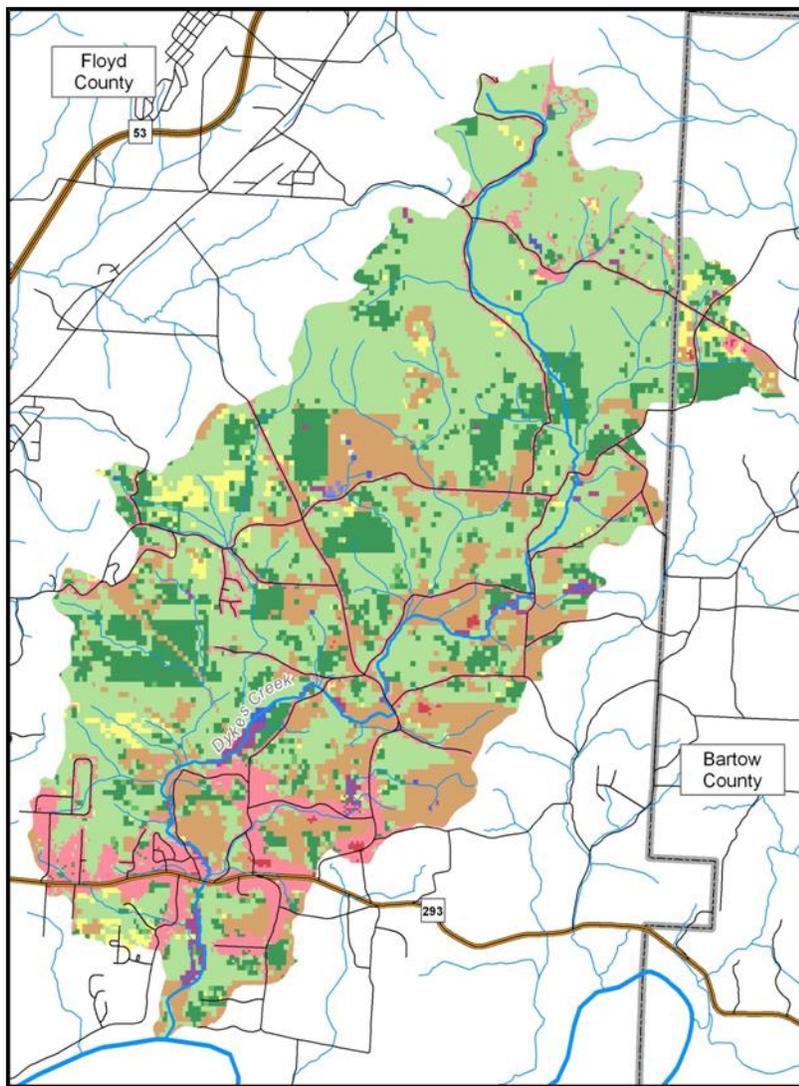
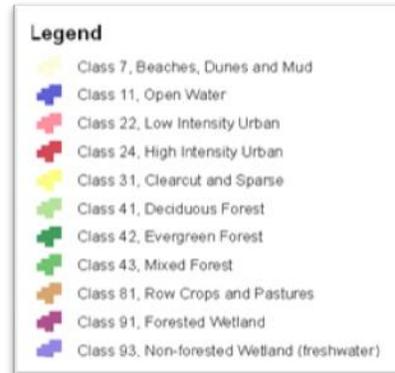
Land type Category	Acres	%
Beaches, Dunes, and Mud (7)	1.77	0.0
Open water (11)	20.87	0.2
Low intensity Urban (22)	1252.00	11.2
High intensity Urban (24)	27.69	0.2
Clearcut and sparse (31)	297.80	2.7
Deciduous Forest (41)	5903.11	52.7
Evergreen Forest (42)	1625.35	14.5
Mixed Forest (43)	63.79	0.6
Row Crops and Pastures (81)	1865.59	16.7
Forested Wetland (91)	130.31	1.2
Non-Forested Wetland (93)	5.10	0.0
total:	11193.38	100

Figure 2.6. A map displaying Dykes Creek watershed land uses and their percentage in the watershed using Georgia Land Use Trends (GLUT) data from 2008.

Comparisons of land use estimates from the EPD (Table 2.2) and GLUT data (Table 2.3) indicate that many of the numbers are similar. However, there are some important differences. The GLUT data lists 1280 acres of urban uses, both low intensity and high intensity, whereas the EPD data lists only 102 acres within the residential and commercial, industrial and transportation categories. The EPD’s category of “Parks, lawns, etc.” (1091 acres) should probably be part of the residential category, since there are no public parks in the watershed. That would somewhat reconcile the difference between the two data sets, because the EPD’s value for residential, commercial, industrial, and transportation would then be 1193 acres. Field observations and aerial photos support this conclusion. Another case where the GLUT data seems to be more accurate is with regard to agricultural use. The EPD data from 2009 shows the amount of row crops at 2,247 acres, and only 211 acres of pasture/hay. The GLUT data lumps together the row crops and pasture, with a total area for this category at 1866 acres. On-the-ground observations indicate that most of this is pasture and hayfields, with very few, if any, row crops in the watershed, as noted above. Neither land use data sets were able to distinguish the small amount of disturbed area from old mines in the upper part of the watershed. These areas show up as urban on the GLUT map along East Hermitage Road.

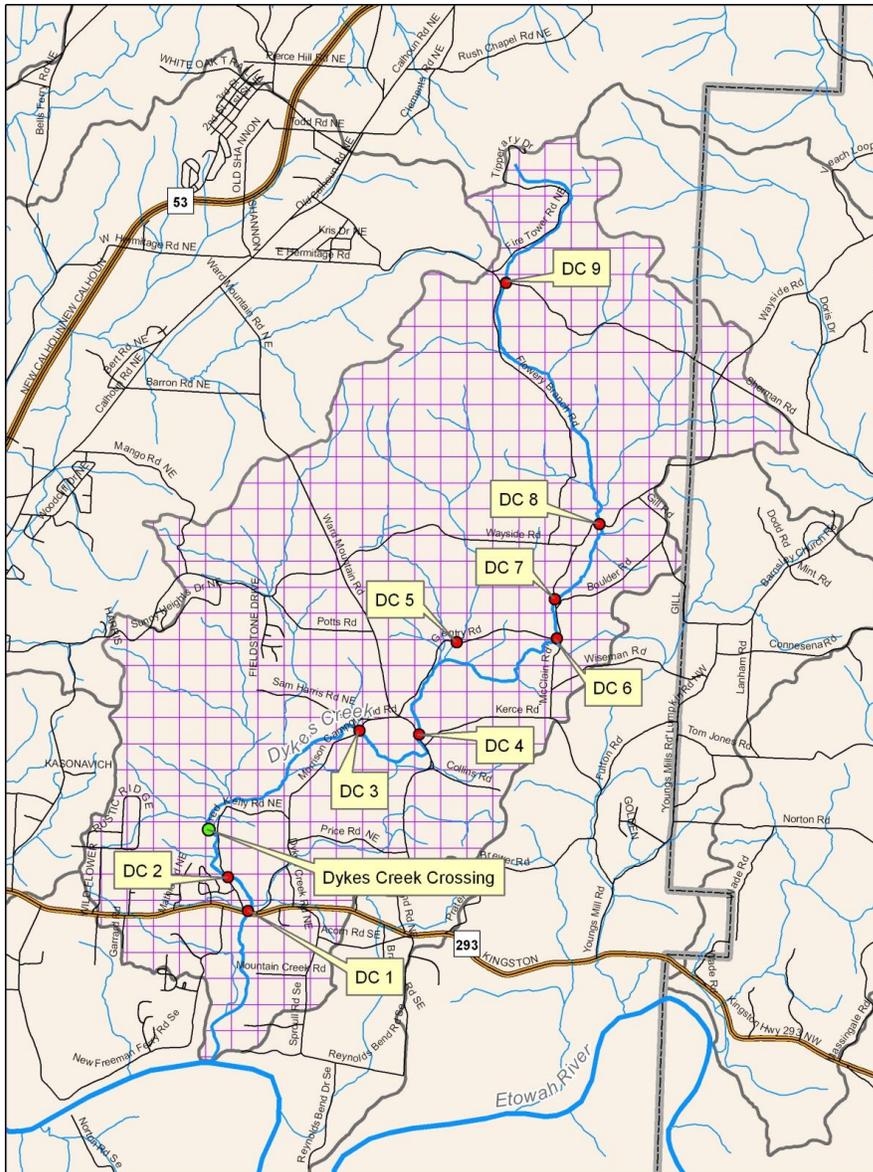
Key to map:	
Kingston Road/SR 293 crossing	DC1
Fred Kelly Road crossing	DC 2
Morrison Campground Road #1 crossing	DC 3
Morrison Campground Road #2 crossing	DC 4
Gentry Road tributary crossing	DC 5
Gentry Road crossing	DC 6
McClain Road crossing	DC 7
Wayside Road crossing	DC 8
East Hermitage Road crossing	DC 9

Figure 3.1. A map showing the location of sites currently sampled by Northwest Georgia Regional Commission.

Water quality data was collected for this study of Dykes Creek by the staff of the Northwest Georgia Regional Commission between August 2013 and May 2014. Water quality parameters being tested on a monthly basis include *E. coli*, Optical brightening agents (OBA's), turbidity, temperature, and conductivity. Optical brightening agents are found in laundry detergent and their presence in stream water has been linked to human sewage leaks. In addition, the macroinvertebrate community was sampled in October, 2013 and May 2014 using the Georgia Adopt-A-Stream macroinvertebrate assessment method. Visual surveys in August 2011 and August 2013 have been used to show the condition of the stream and surrounding watershed, with photos taken to record conditions. Nine sites, eight of which are on the main stem of the creek, were sampled. The sites are shown in Figure 3.1.

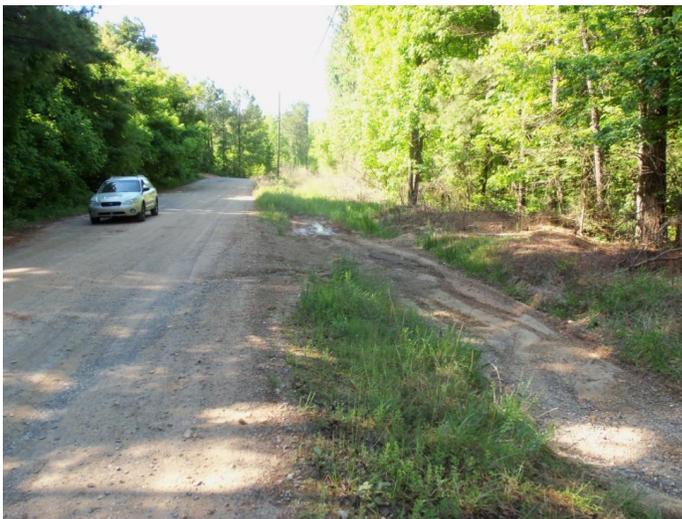
Figure 3.2. Road in Shannon Oaks Subdivision off of Firetower Road. Note large accumulation of sediment on right from road.

At the very top of the watershed on Armstrong Mountain, off of Firetower Road, is an area of unpaved roads. These roads are not county roads. The area was subdivided in the 1980's, given the name of Shannon Oaks subdivision, and lots were sold. Some of the lots have been built on, but many of them are undeveloped. The main unpaved road leads off of Firetower Road and forms a loop into this wooded area. Two other unpaved roads lead off of it. Mileage in the Dykes Creek watershed of this group of roads is 0.5 miles (the full mileage of these unpaved roads is much greater, but it is outside of the watershed). The roads are very wide in places, as much as 25 feet wide, and are in terrible condition, with steep sections, potholes and no gravel. During wet winter weather it is clear that sediment is moving off the road and into the forest. (See Figure 3.2). Although the headwaters of Dykes Creek do not flow all year round, in February 2014 Dykes Creek was flowing. Homes are located in this area with unpaved drives that also potentially contribute sediment to Dykes Creek and its headwater tributaries. Continuing southward on Firetower Road are more unpaved driveways, some of which are in poor condition.

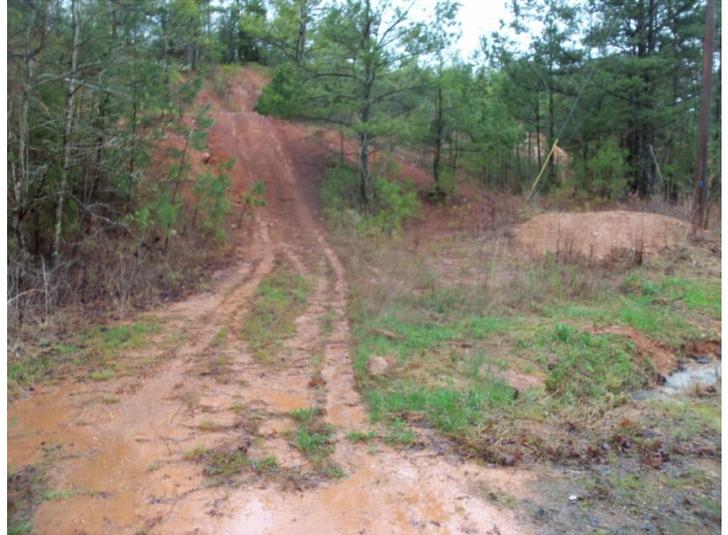
Figure 3.3. Old bauxite mine tailings site off East Hermitage Road.

An old bauxite mine site is located along East Hermitage Road. This is a pit mine that filled with water while the mine was still active in the mid 20th century. The tailings for the pit are piled on the south side of the road in two areas. Field observations of one of the areas revealed that these tailings have trees growing on them, but much of the ground is bare dirt with gullies (see Figure 3.3). The area that these two piles of tailings cover is about 13.75 acres. Erosion from these sites would enter an unnamed tributary on the east side of the watershed. Materials from these mining sites would not affect the extreme upper reaches of Dykes Creek, including the East Hermitage Road site, because this eastern tributary enters the main branch of Dykes Creek further downstream. Materials moving off this site would enter the ditch and flow into a tributary of Dykes Creek.

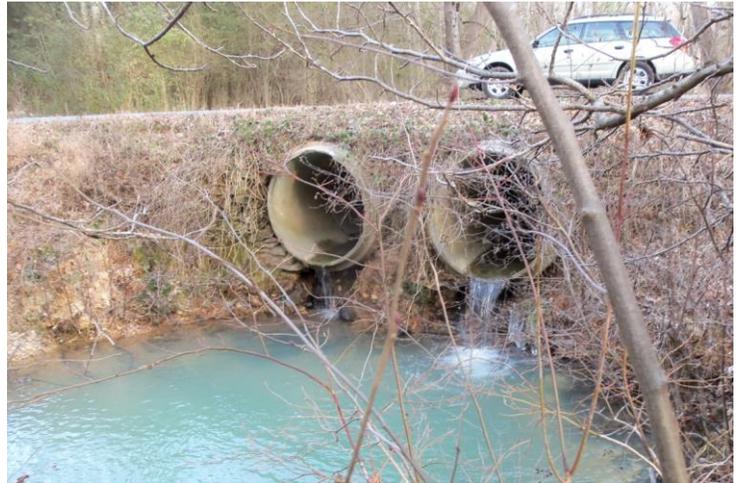
Figure 3.4. Overshot, failed culvert on E. Hermitage Road. Note the milky appearance of the water.

The stream crossing on East Hermitage Road is a double culvert in poor condition (Figure 3.4). The area underneath the culvert has eroded out so that water flows underneath the culvert. The culvert is overshot so that a plunge pool has been created and the banks are eroded. The culvert needs to be replaced and properly aligned so that there is no plunge pool. The ditches leading to this culvert are eroded, although effort has been made to create check dams with riprap. Downstream of the culvert the creek is downcut, probably a result of past timber harvest leading to increased flow in the 20th century.

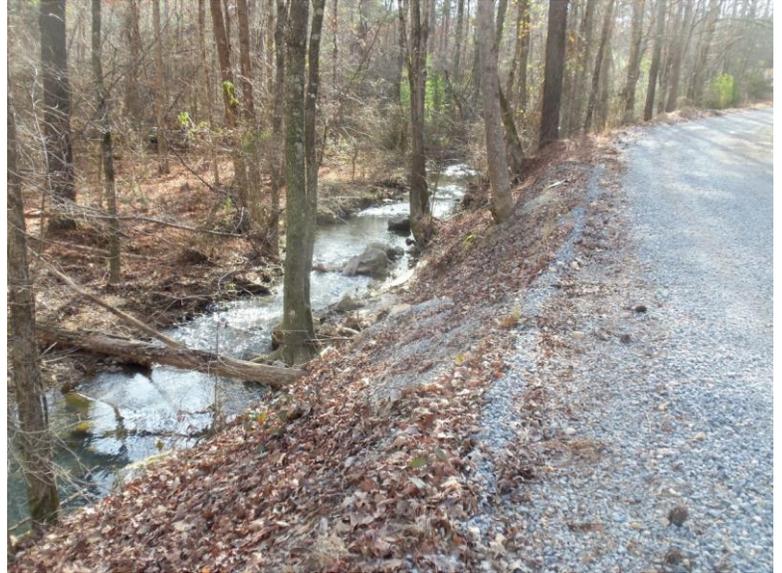
Figure 3.5. Photo showing unpaved section of Flowery Branch Road with gravel washing down the bank into Dykes Creek.

Continuing south on Flowery Branch Road, a section of the road is unpaved, but graveled. This section is 0.9 miles long. The creek is very close to the road for about 50 yards and the gravel is going straight into the creek (Figure 3.5).

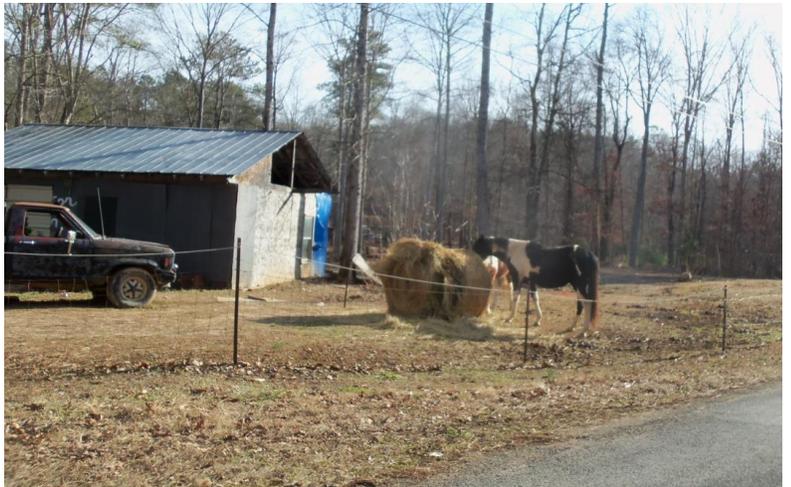
Figure 3.6. Hobby farming with horses in pasture with creek flowing through pasture.

In the Flowery Branch area and other areas in the watershed, hobby farming with animal enclosures near the creek or encompassing the creek is occurring (Figures 3.6). Several large cow pastures area located in the watershed as well.

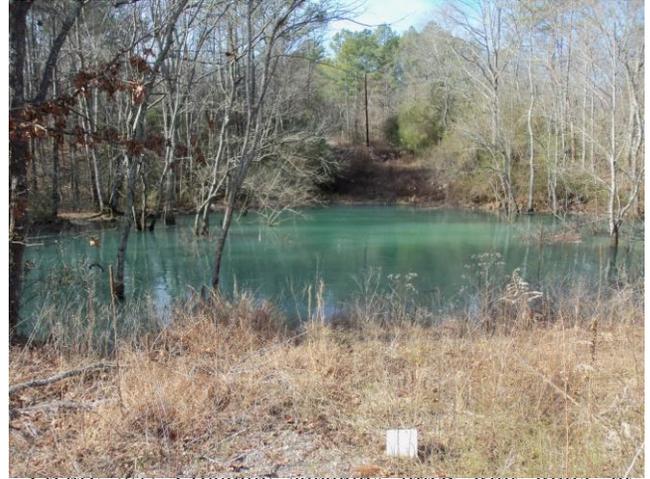
Figure 2-11. Possible sediment, joined with water, in January 2014, on Dykes Creek at Gentry Road Bridge.

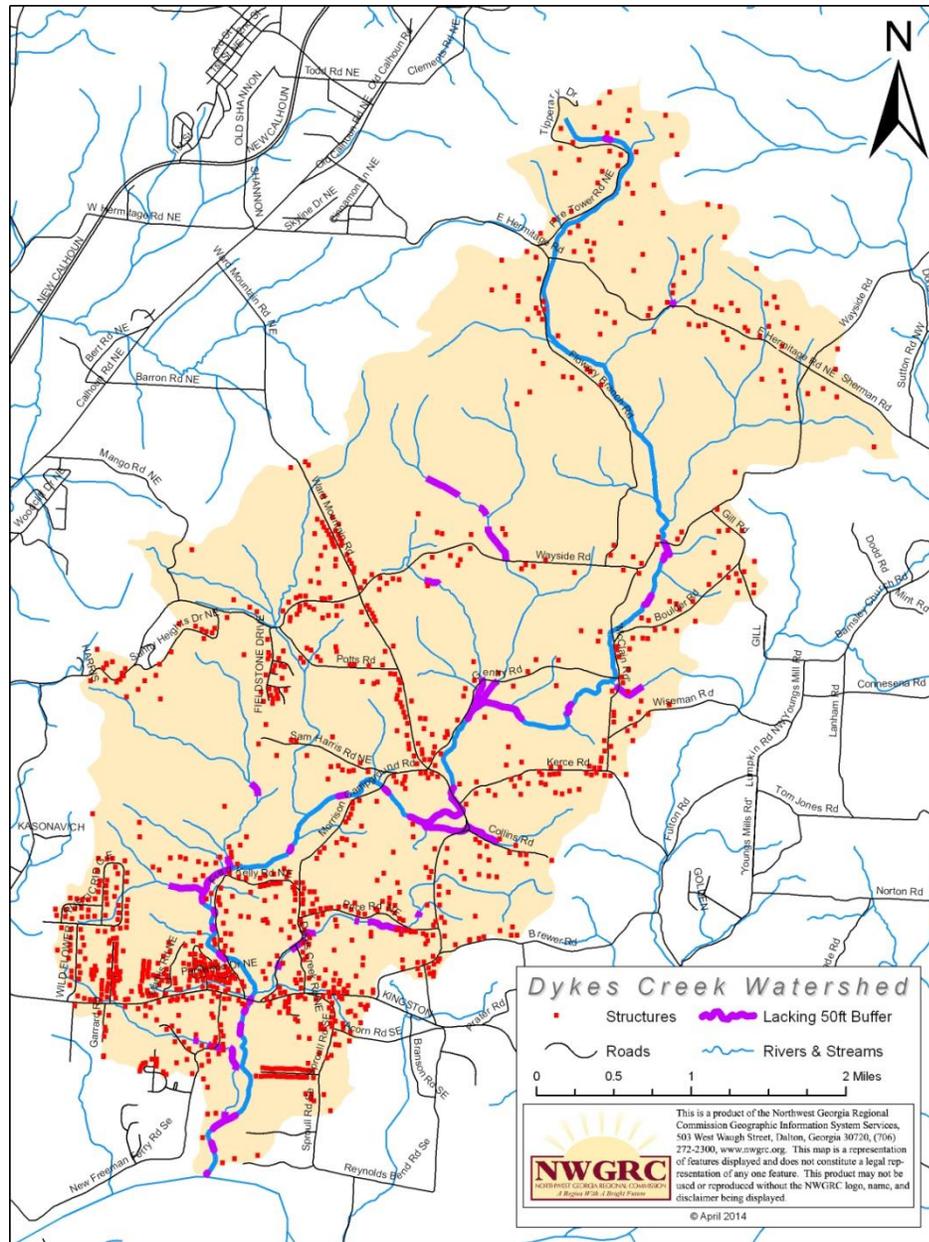
Figure 3.8. Map of insufficient 50 foot riparian buffers and total residential/business structures expected to have septic systems in the watershed.

The map in Figure 3.8 shows all the residential/business structures as red dots in the Dykes Creek watershed, which equals 1,085 buildings with septic systems. The streamside areas lacking 50 foot naturally vegetated forest buffers, marked in purple, include 2.1 miles along the main Dykes Creek and 3.2 miles on the tributaries, for a total of 5.3 miles of missing buffers.

The above discussion has identified several specific fecal coliform and sediment problems in the watershed that could be addressed with structural land management practices. Unpaved roads in the upper watershed could be paved or receive much needed regular maintenance. The old mine tailing sites off East Hermitage Road could be stabilized with grading and vegetation. At least one culvert, the one on East Hermitage Road, could be replaced. The establishment of a cost-share program for the implementation of agricultural BMP's and restoring streamside buffers would be useful in controlling sediment and fecal coliform off of pasture areas. A septic system repair program would help control fecal coliform moving off of residential areas with failing septic systems. Based on US EPA estimates that 10% of septic systems in the US are not working properly, the number of septic systems to fix, 109, was calculated from the 1,085 residential/business structures in the watershed (Figure 3.8).

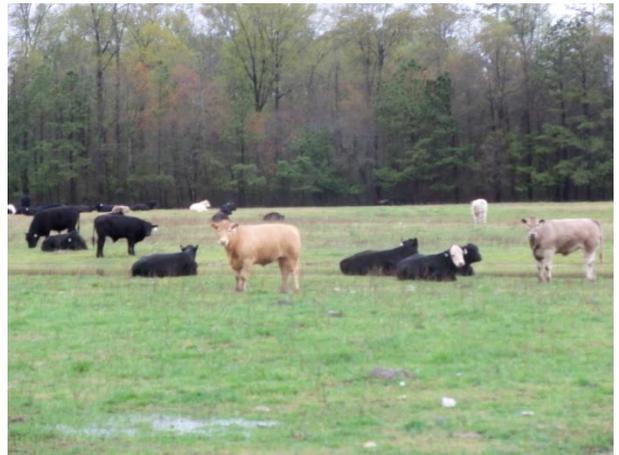
Figure 4.1. Cows in pasture on Wayside Road.

Table 4.1 shows the overall population of livestock in the two counties in which Dykes Creek watershed lies. According to land use data provided in the state document for listing Dykes Creek as impaired (GA DNR EPD 2009), and shown in Table 2.3 of this document, the agricultural land use is 22.4%. Percentage of agricultural land use is 16.7% from the GLUT data shown in Table 2.3. These percentages seem low, but presence of livestock on the creek and its tributaries is evident as discussed above in Section 3.3 (Figure 4.1). During storm sampling events in March 2014 and April 2014, *E. coli* was not as high in the uppermost part of the watershed where it is more wooded and where there is almost no pasture (see Table 3.7). This suggests that wildlife alone are not to blame for the high fecal coliform values. Agricultural sources of fecal coliform are probably significant. Fecal coliform is probably washing off the various pasture areas in the middle area of the watershed. Pastures near and on the creek could be a source of sediment as well.
