**STATE OF GEORGIA
TIER 2 TMDL Implementation Plan (Revision # 01)**

Segment Name: Little River Date: 9/30/2009

River Basin: Tallapoosa River

Plan for Little River
HUC 10 # 0315010801

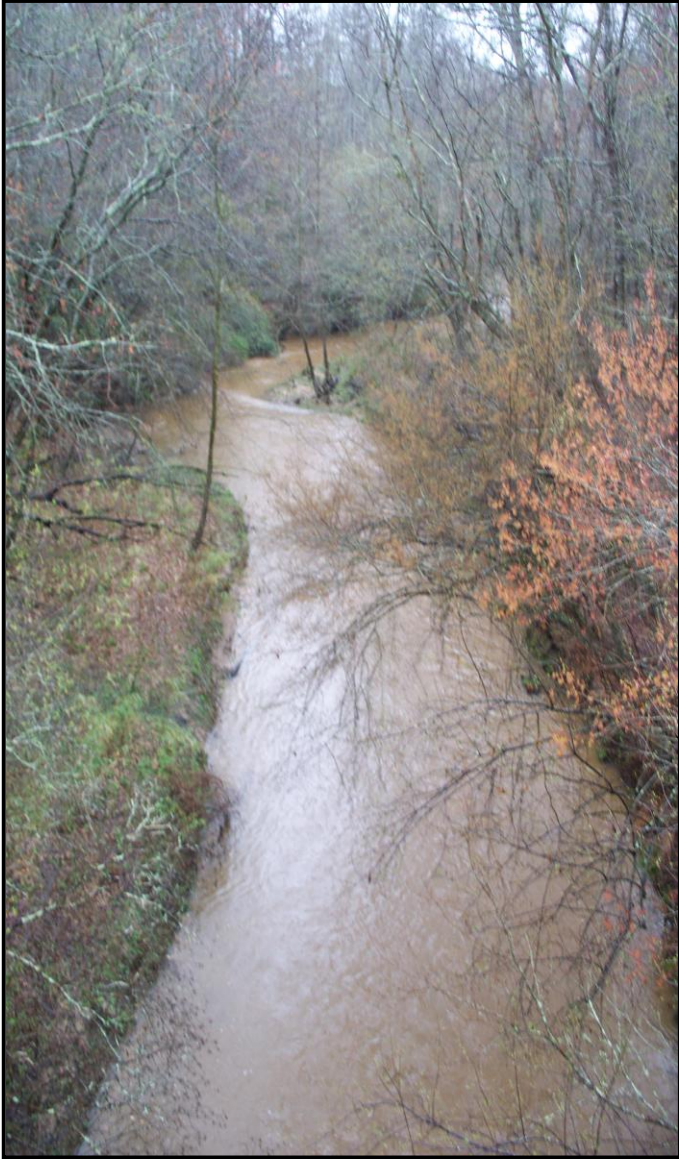
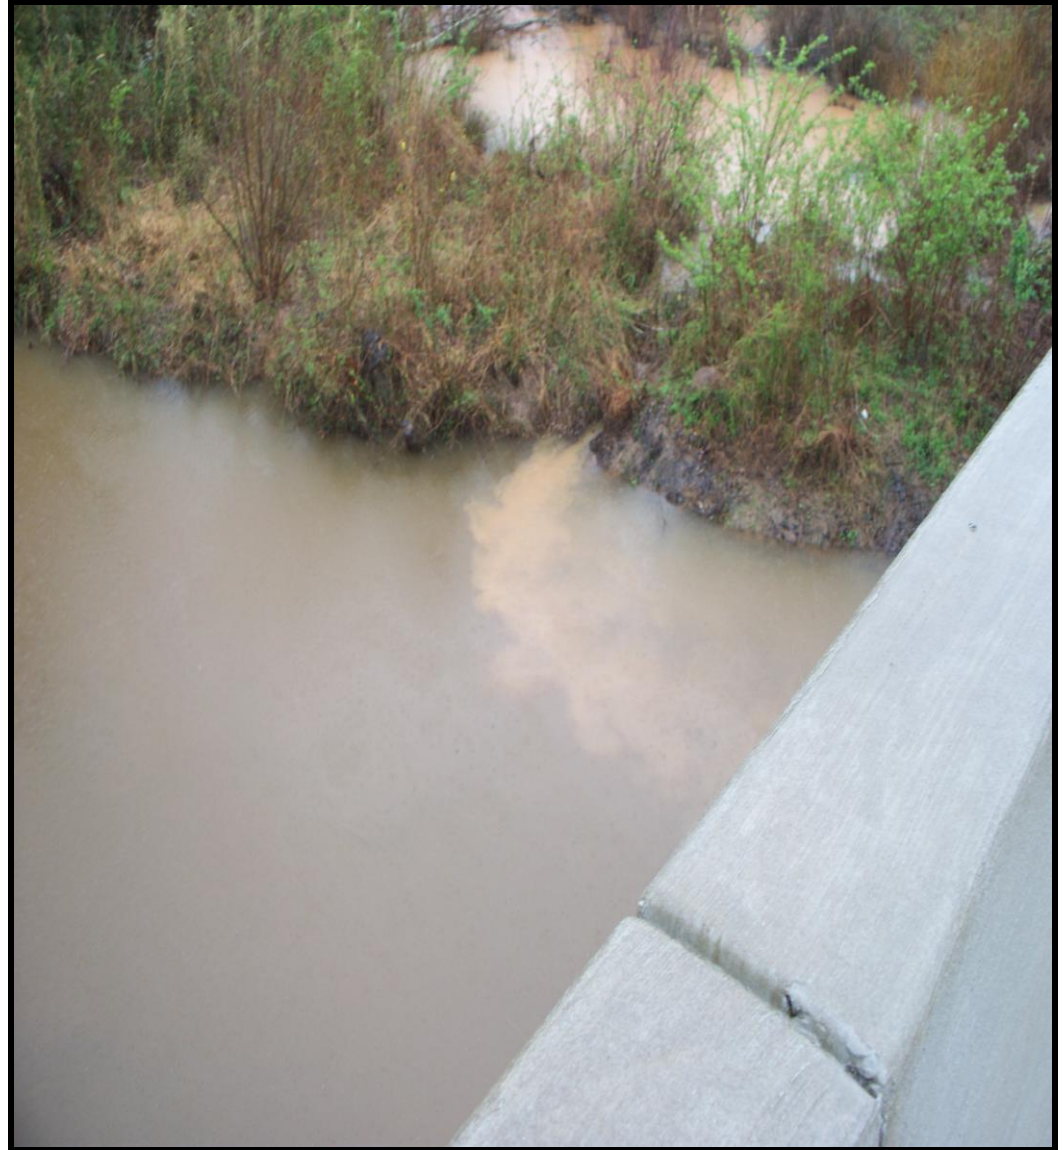
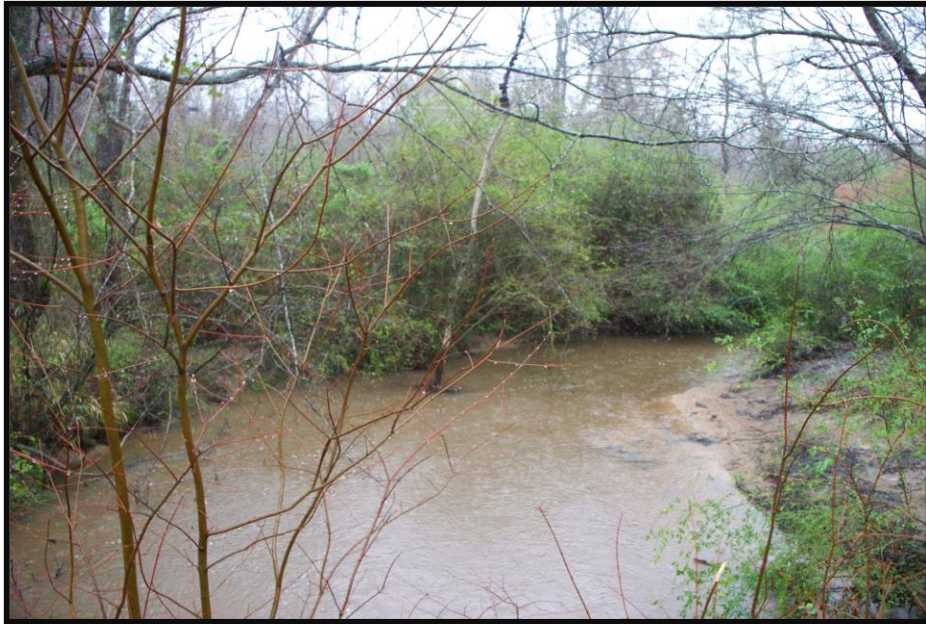
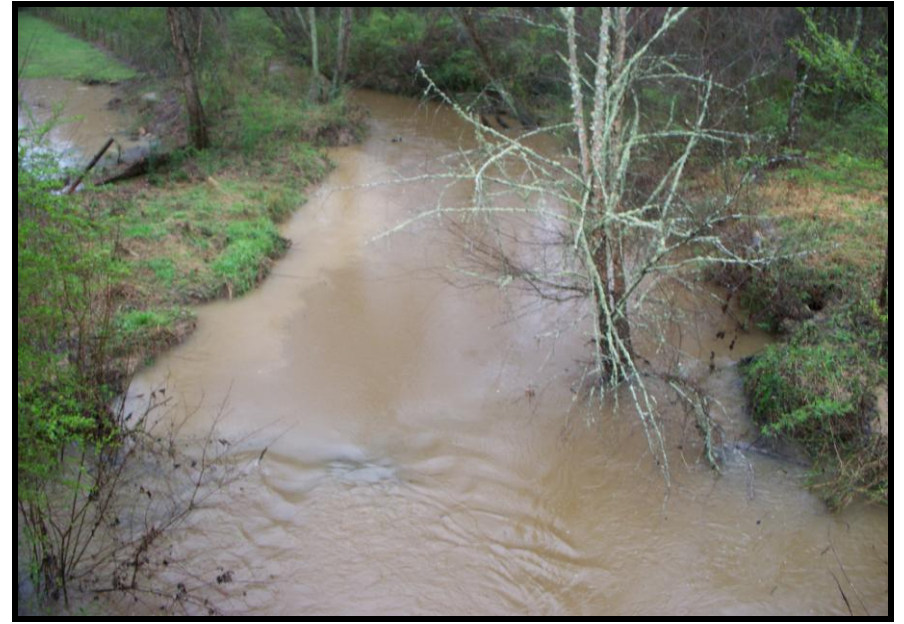
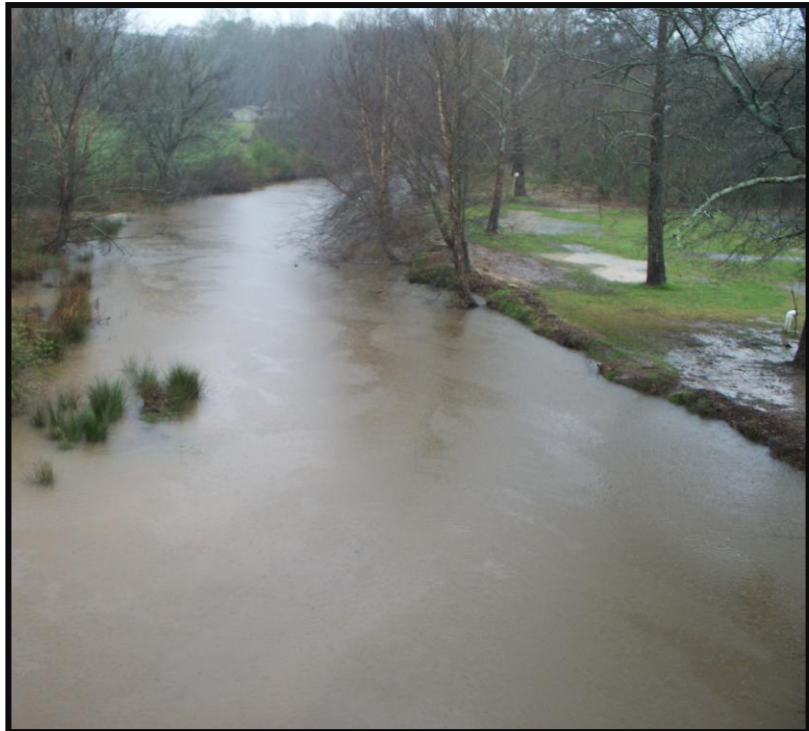
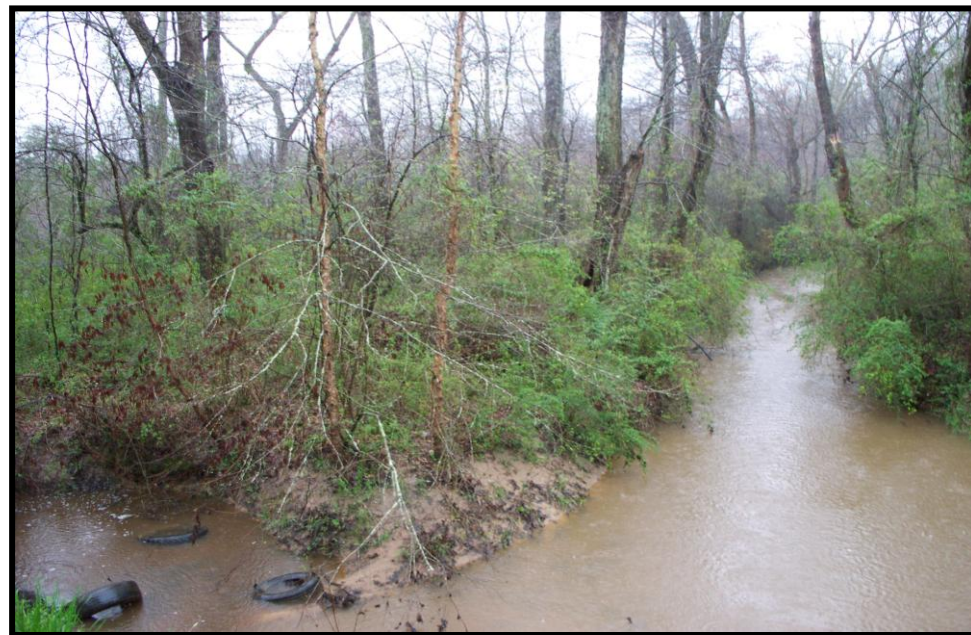
VISUAL FIELD SURVEYS, NOTES, PHOTOGRAPHS, AND MAPS.

The NWGRC conducted a visual creek and sub-watershed land use verification on a rainy March 27, 2009. There was a high degree of runoff of sediment, and possibly also bacteria from agricultural and pet runoff into the river as it had rained previous to the visual survey. With such a large area being forested, wildlife is likely to contribute to the problem. No houses were seen directly on the river bank and no evidence was seen of a leaking septic tank, but all of the residences are on septic in the watershed area. There are some houses along with a ballpark and a small marina on the Lake Olympia (locally known as Lake Sea breeze), which is part of the Little River. There was a fairly new subdivision in the area near the downstream area – presumably on septic tank. The road crossings visited were: side dirt Rd. off of Hoke Golden Rd., Morgan Road, Corinth Poseyville Road, GA Hwy. 120/Lake Olympia (Seabreeze), Five Points Road, and East Church Road.

The visual survey of the Little River drainage area was conducted on March 27, 2009 by the staff of the Northwest Georgia Regional Commission. Photographs of the stream channel were taken, and the survey of the land use, wildlife, stream conditions, and weather conditions were recorded. A visual survey and satellite photography of the area contradicted two land use categories established for the Little River HUC 12. The surveyors saw significant agricultural use, but much less row crops than stated - 27% - and a large proportion of pastureland, hay fields than stated in the study documents – 0%. Other than that discrepancy, the land use surveyed fell in line with what was stated in the TMDL study document.

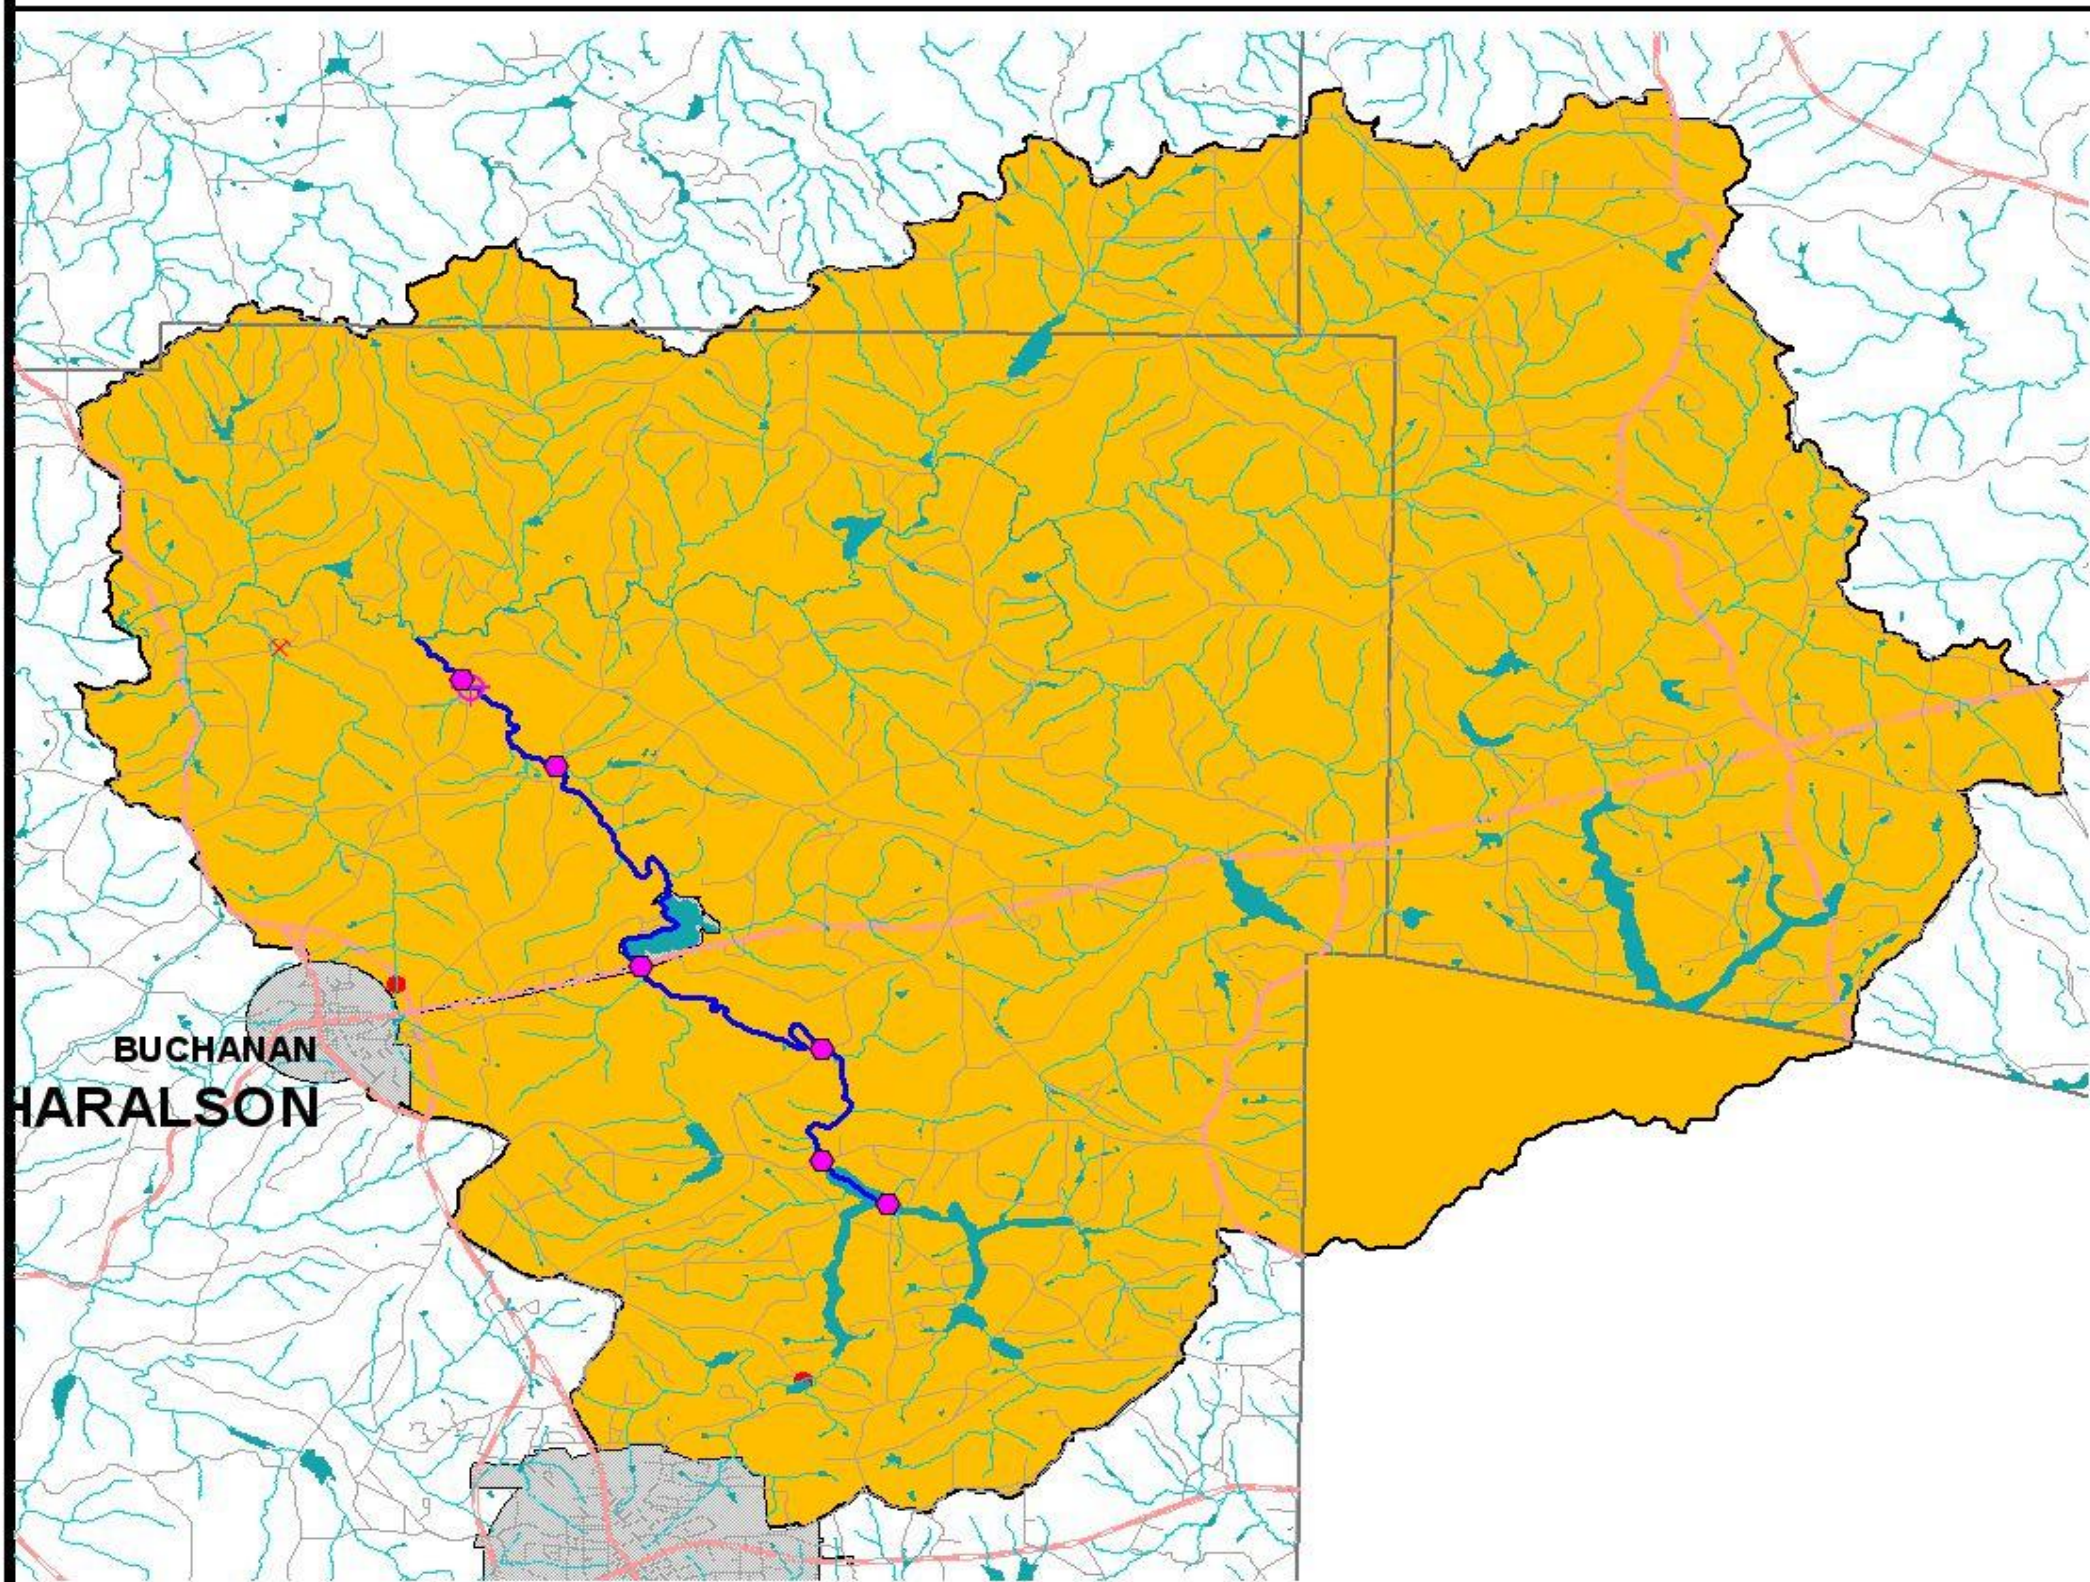
**Little River
Upper Tallapoosa Watershed
HUC10# 0315010801**

Baxter Creek To Tallapoosa River

- Water Quality Monitoring Stations 2009
- USGS Water Quality Monitoring Stations 2001
- USGS Water Quality Monitoring Stations 2005
- EPD Water Quality Monitoring Stations
- Field Survey Locations 2009
